Home > Instructions & Guides > Harley CV Carburetor Tuning Issues

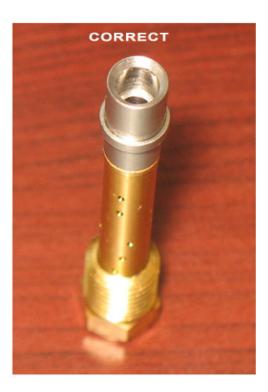
2) Check that the needle jet (nozzle) is installed correctly. Installing the jet upside down will adversely impact the fuel spray and needle metering.

If your needle jet is missing or worn CVP carries new needle jets.
